**WALNUT HOLLOW LAKE DAM  
IRON COUNTY, MISSOURI  
MO 30619**

**PHASE 1 INSPECTION REPORT  
NATIONAL DAM SAFETY INSPECTION**

**WALNUT HOLLOW LAKE DAM**

**Phase I Inspection Report  
National Dam Safety Program**

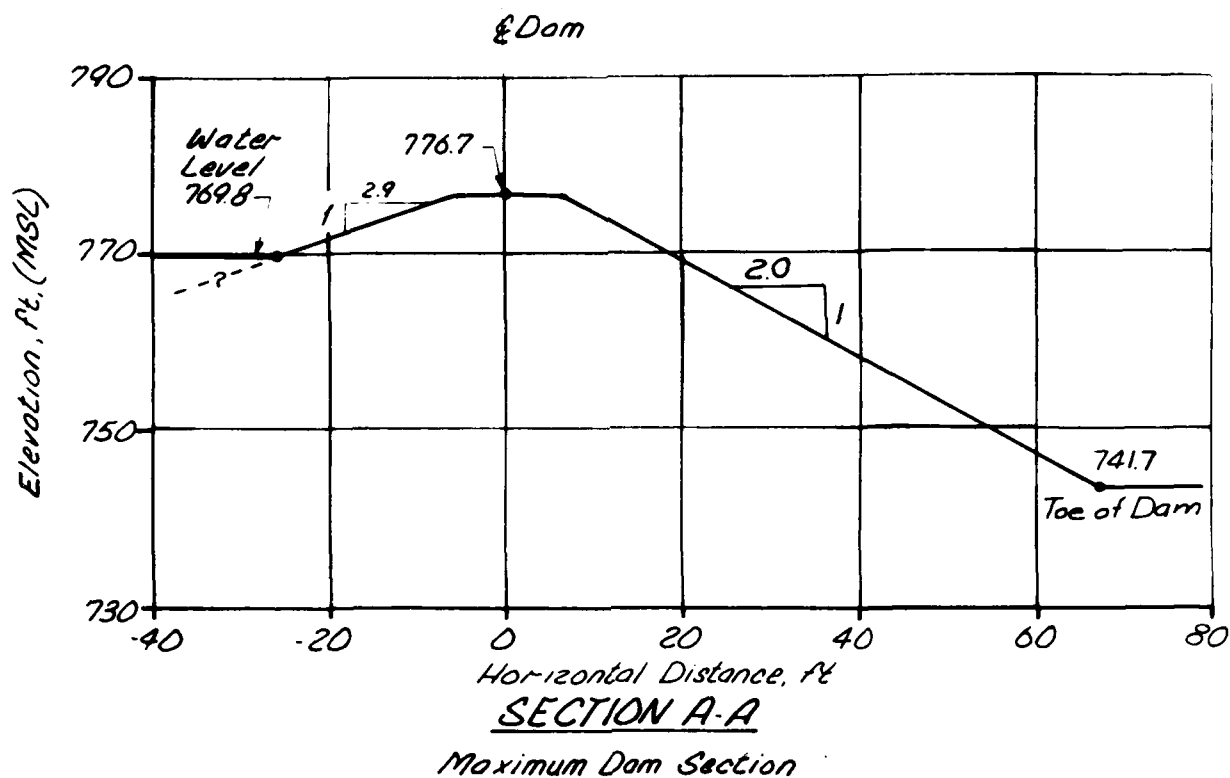
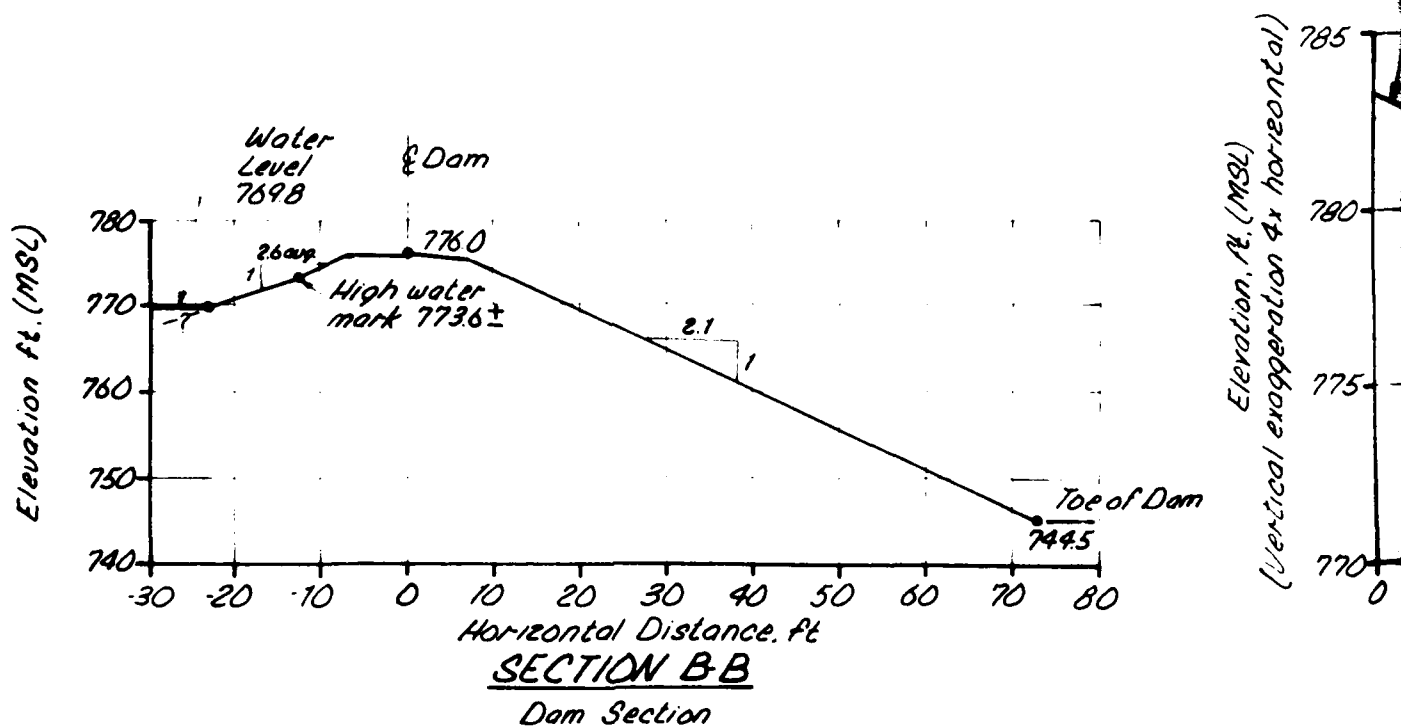
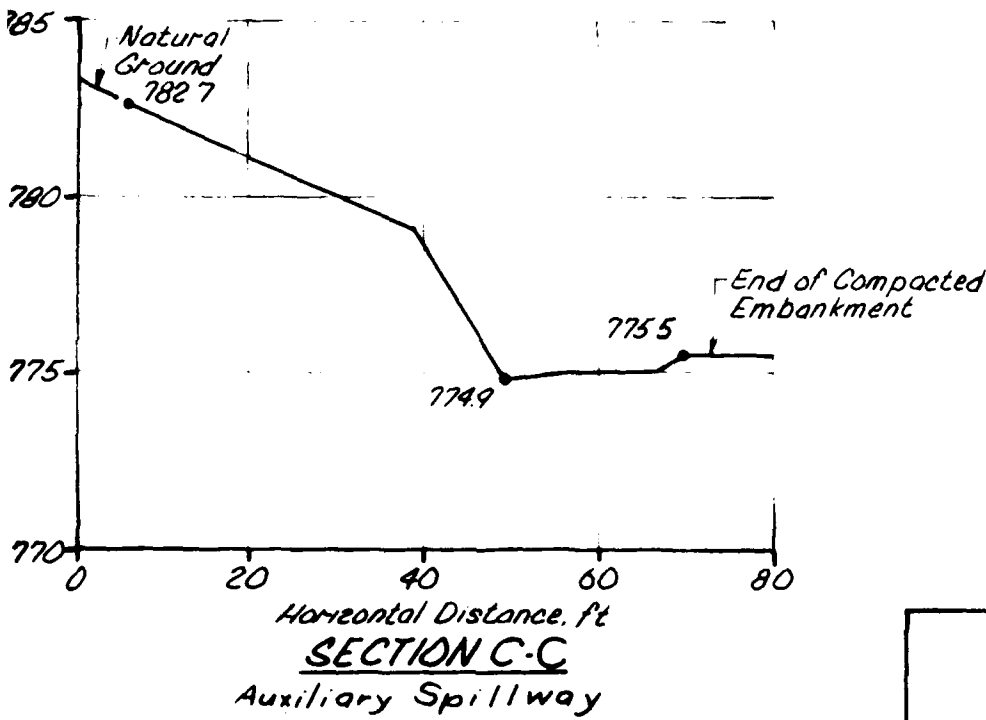
SECTIONS OF	
DAM AND SPILLWAY	
WALNUT HOLLOW LAKE DAM	
MO 30619	Fig. 3-B

The auxiliary spillway is a trapezoidal, unlined notch cut into the native gravelly soil at the right abutment (Photo 6). This spillway is noticeably shallow and was surveyed to be only 0.6 ft below the adjacent compacted embankment (Fig 3-B). There is no evidence of any prior flow over the auxiliary spillway.

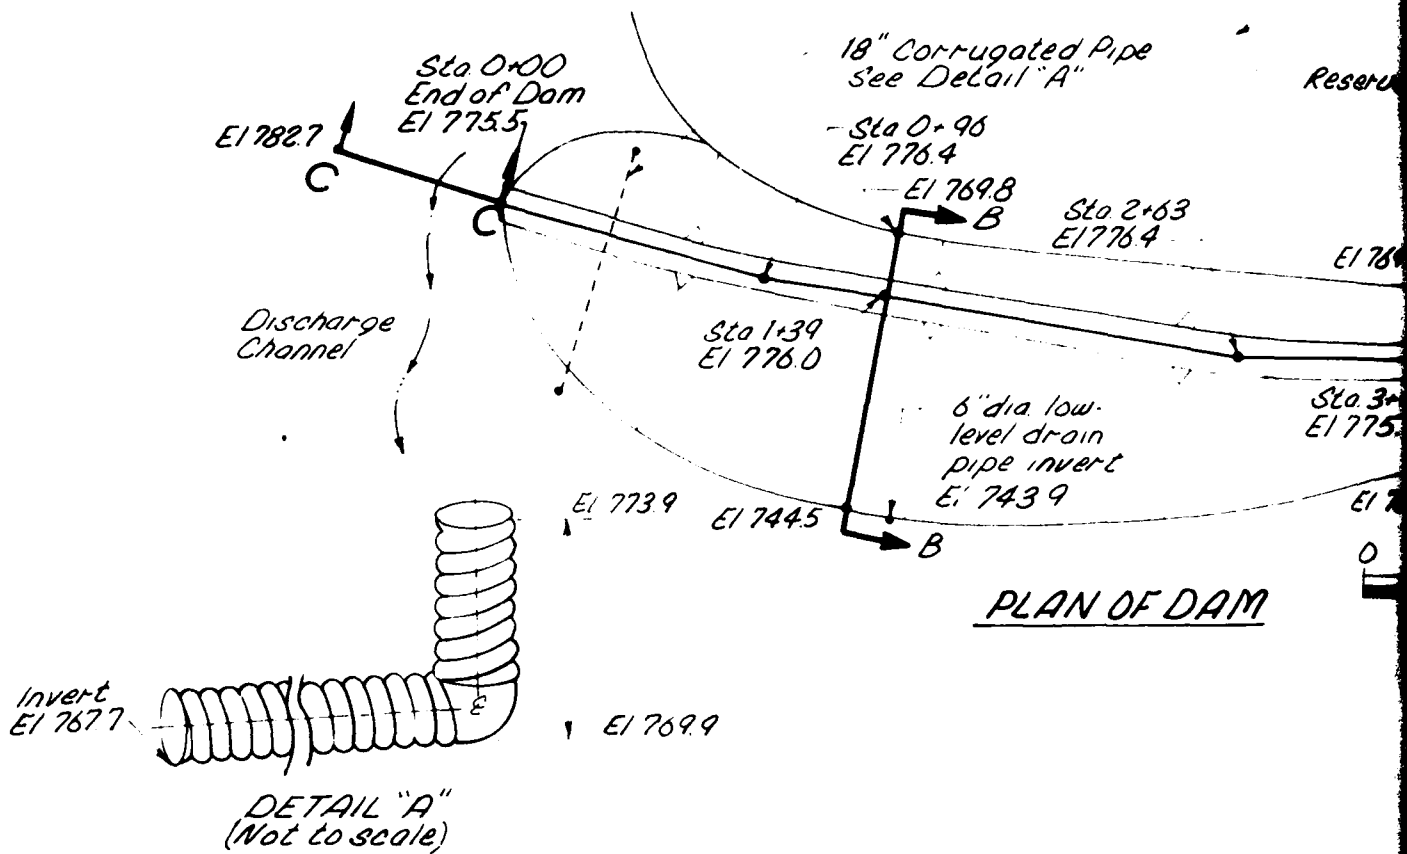
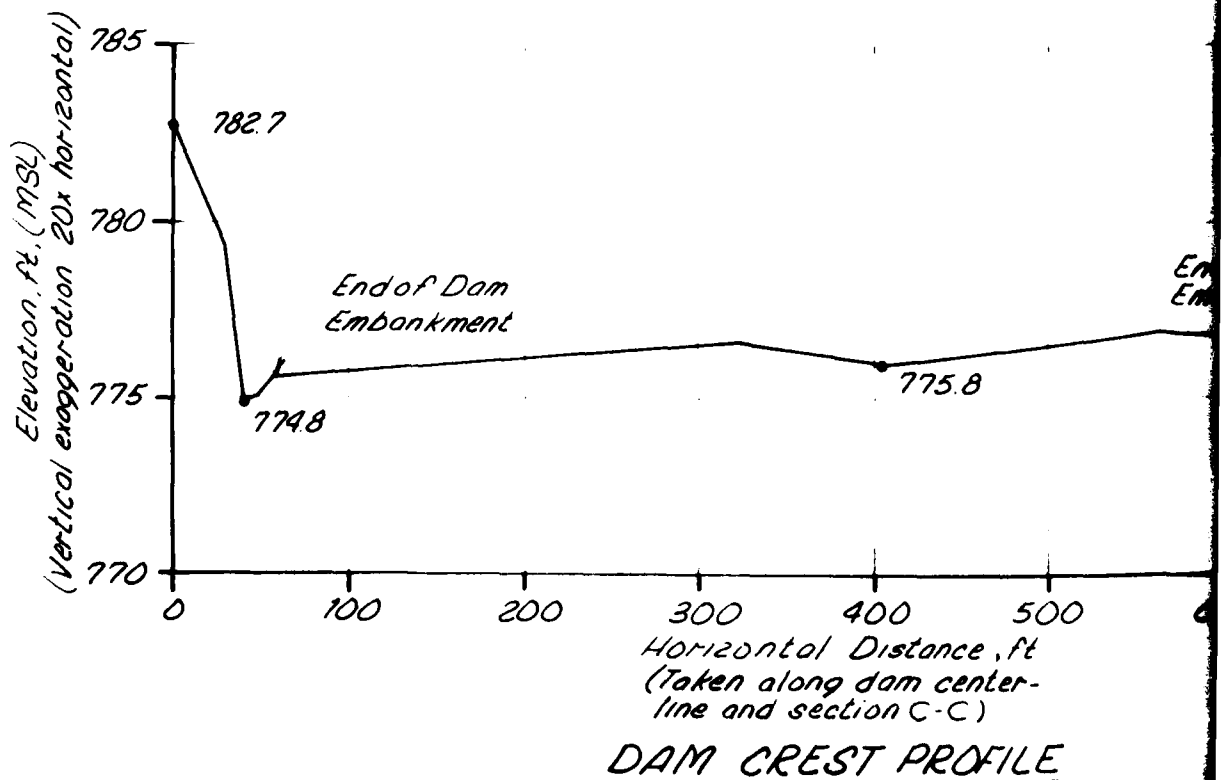
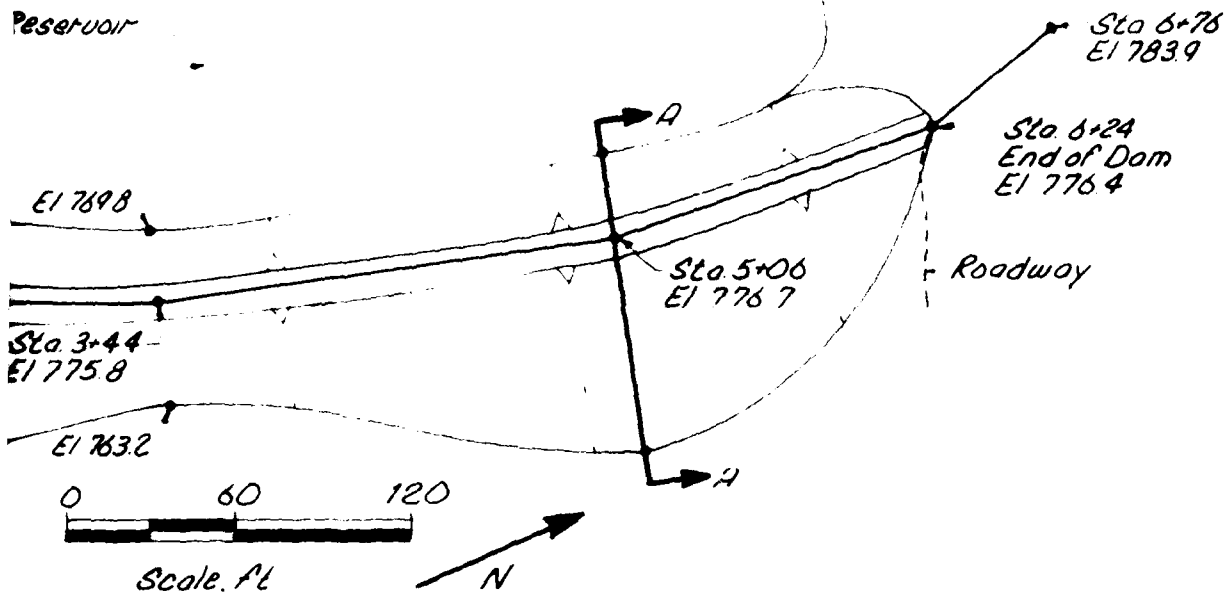
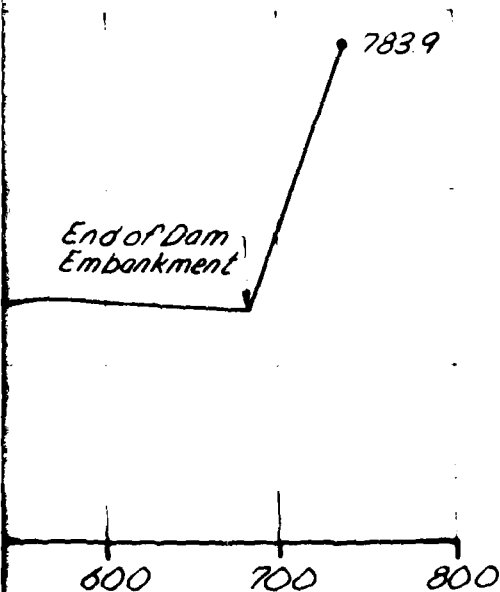
Fig. 3-A

- a. Description of dam and appurtenances. Walnut Hollow Lake Dam is an earth dam impounding a lake used for recreational purposes. The dam was constructed in an arc, convex in a downstream direction, and crosses two small drainages separated by a small hill. The result is a rise in the elevation of the base of the dam near the center of the embankment (Fig 3-A; and Fig A-1, Appendix A).

- c. **Appurtenant structures.** The main spillway consists of an uncontrolled, 18-in. diameter corrugated galvanized pipe; the configuration is shown in Fig 3-A. The inlet is not protected by a trash rack (Photo 4) and the outlet discharges near the toe of the embankment into a wooded area (Photo 5). There is some evidence of limited prior flow through the main spillway. Both inlet and outlet are located near the right abutment.
